# Manhole Inspection Summary

Manhole # S15II1015MH

Insp Date: **11/28/06 2:09 PM**

**Location** Address: **2804 OAKFORD AVE**

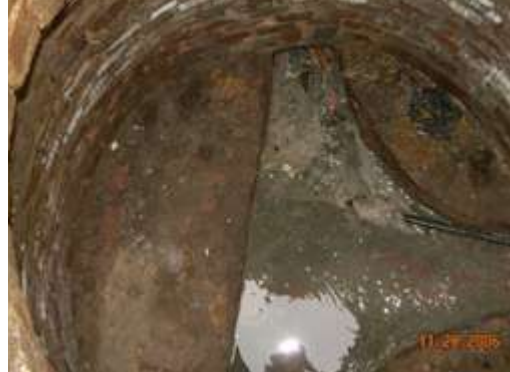
Top View

Evidence of surcharge - Bench debris.  
Channel debris.

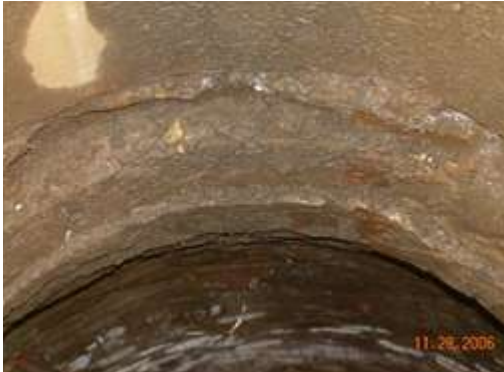
Defect

Frame leaks. Adjustment infiltration.

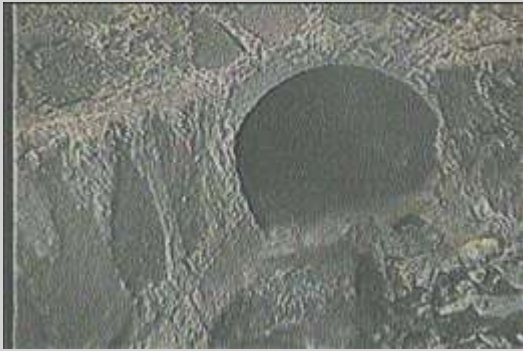
### 8 in. Circular Gravity Sewer Pipe Out @ 12 O'Clock

Deposits: ☐ None ☐ Mud ☐ Sludge ☒ **Debris** ☐ Grease

Silt Depth: **0.5** (in.) Deposits Extent: **Light**

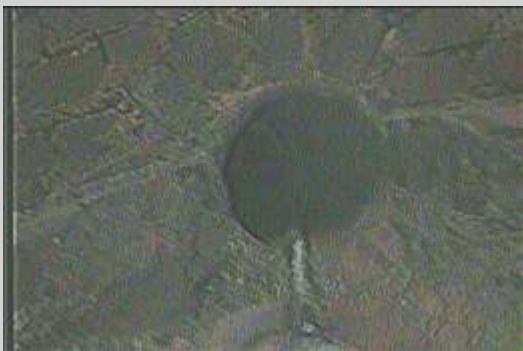
### 8 in. Circular Gravity Sewer Pipe In @ 3 O'Clock

Deposits: ☐ None ☒ **Mud** ☐ Sludge ☒ **Debris** ☐ Grease

Silt Depth: **0.5** (in.) Deposits Extent: **Light**

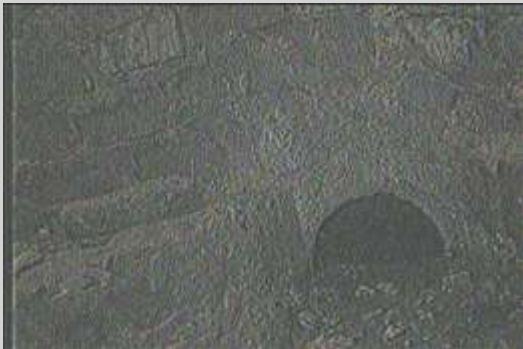
6 in. Circular Gravity Sewer  
Pipe In @ 6 O'Clock

Deposits: ☐ None ☐ Mud ☐ Sludge ☒ **Debris** ☐ Grease

Silt Depth: **3** (in.) Deposits Extent: **Medium**
